GEORGIA-PACIFIC – LINNTON FIBER TERMINAL CSM Site Summary

GEORGIA-PACIFIC – LINNTON FIBER TERMINAL

Oregon DEQ ECSI #: 2370

1. SUMMARY OF POTENTIAL CONTAMINANT TRANSPORT PATHWAYS TO THE RIVER

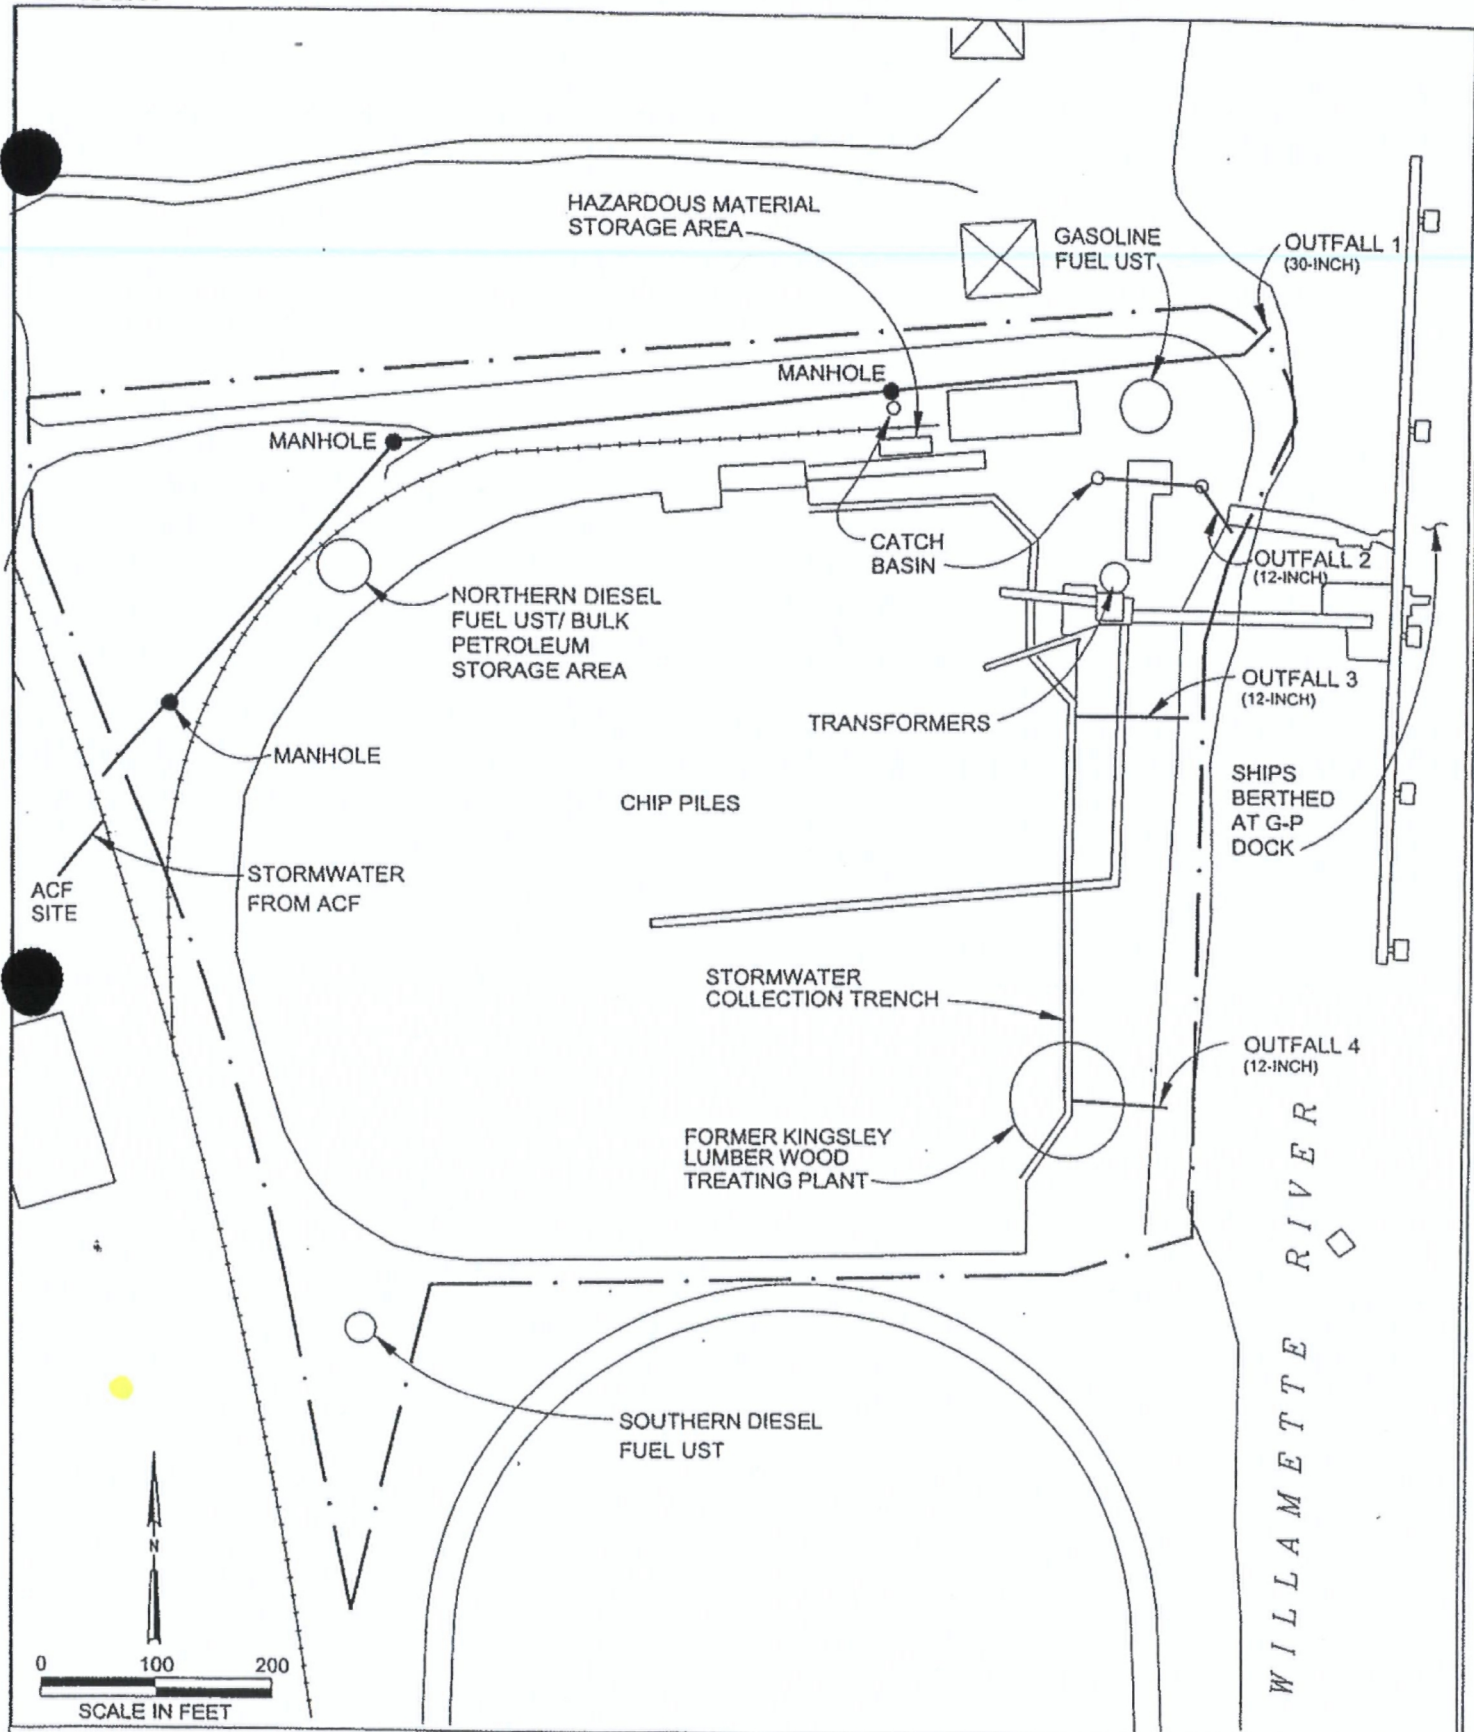
Figure 3-3
SOURCE / PATHWAY
LOCATIONS

Supplemental Preliminary Assessment Report
for the Linnton Site

Figure 3-3. Source/Pathway Locations (CH2M HILL 2000a)

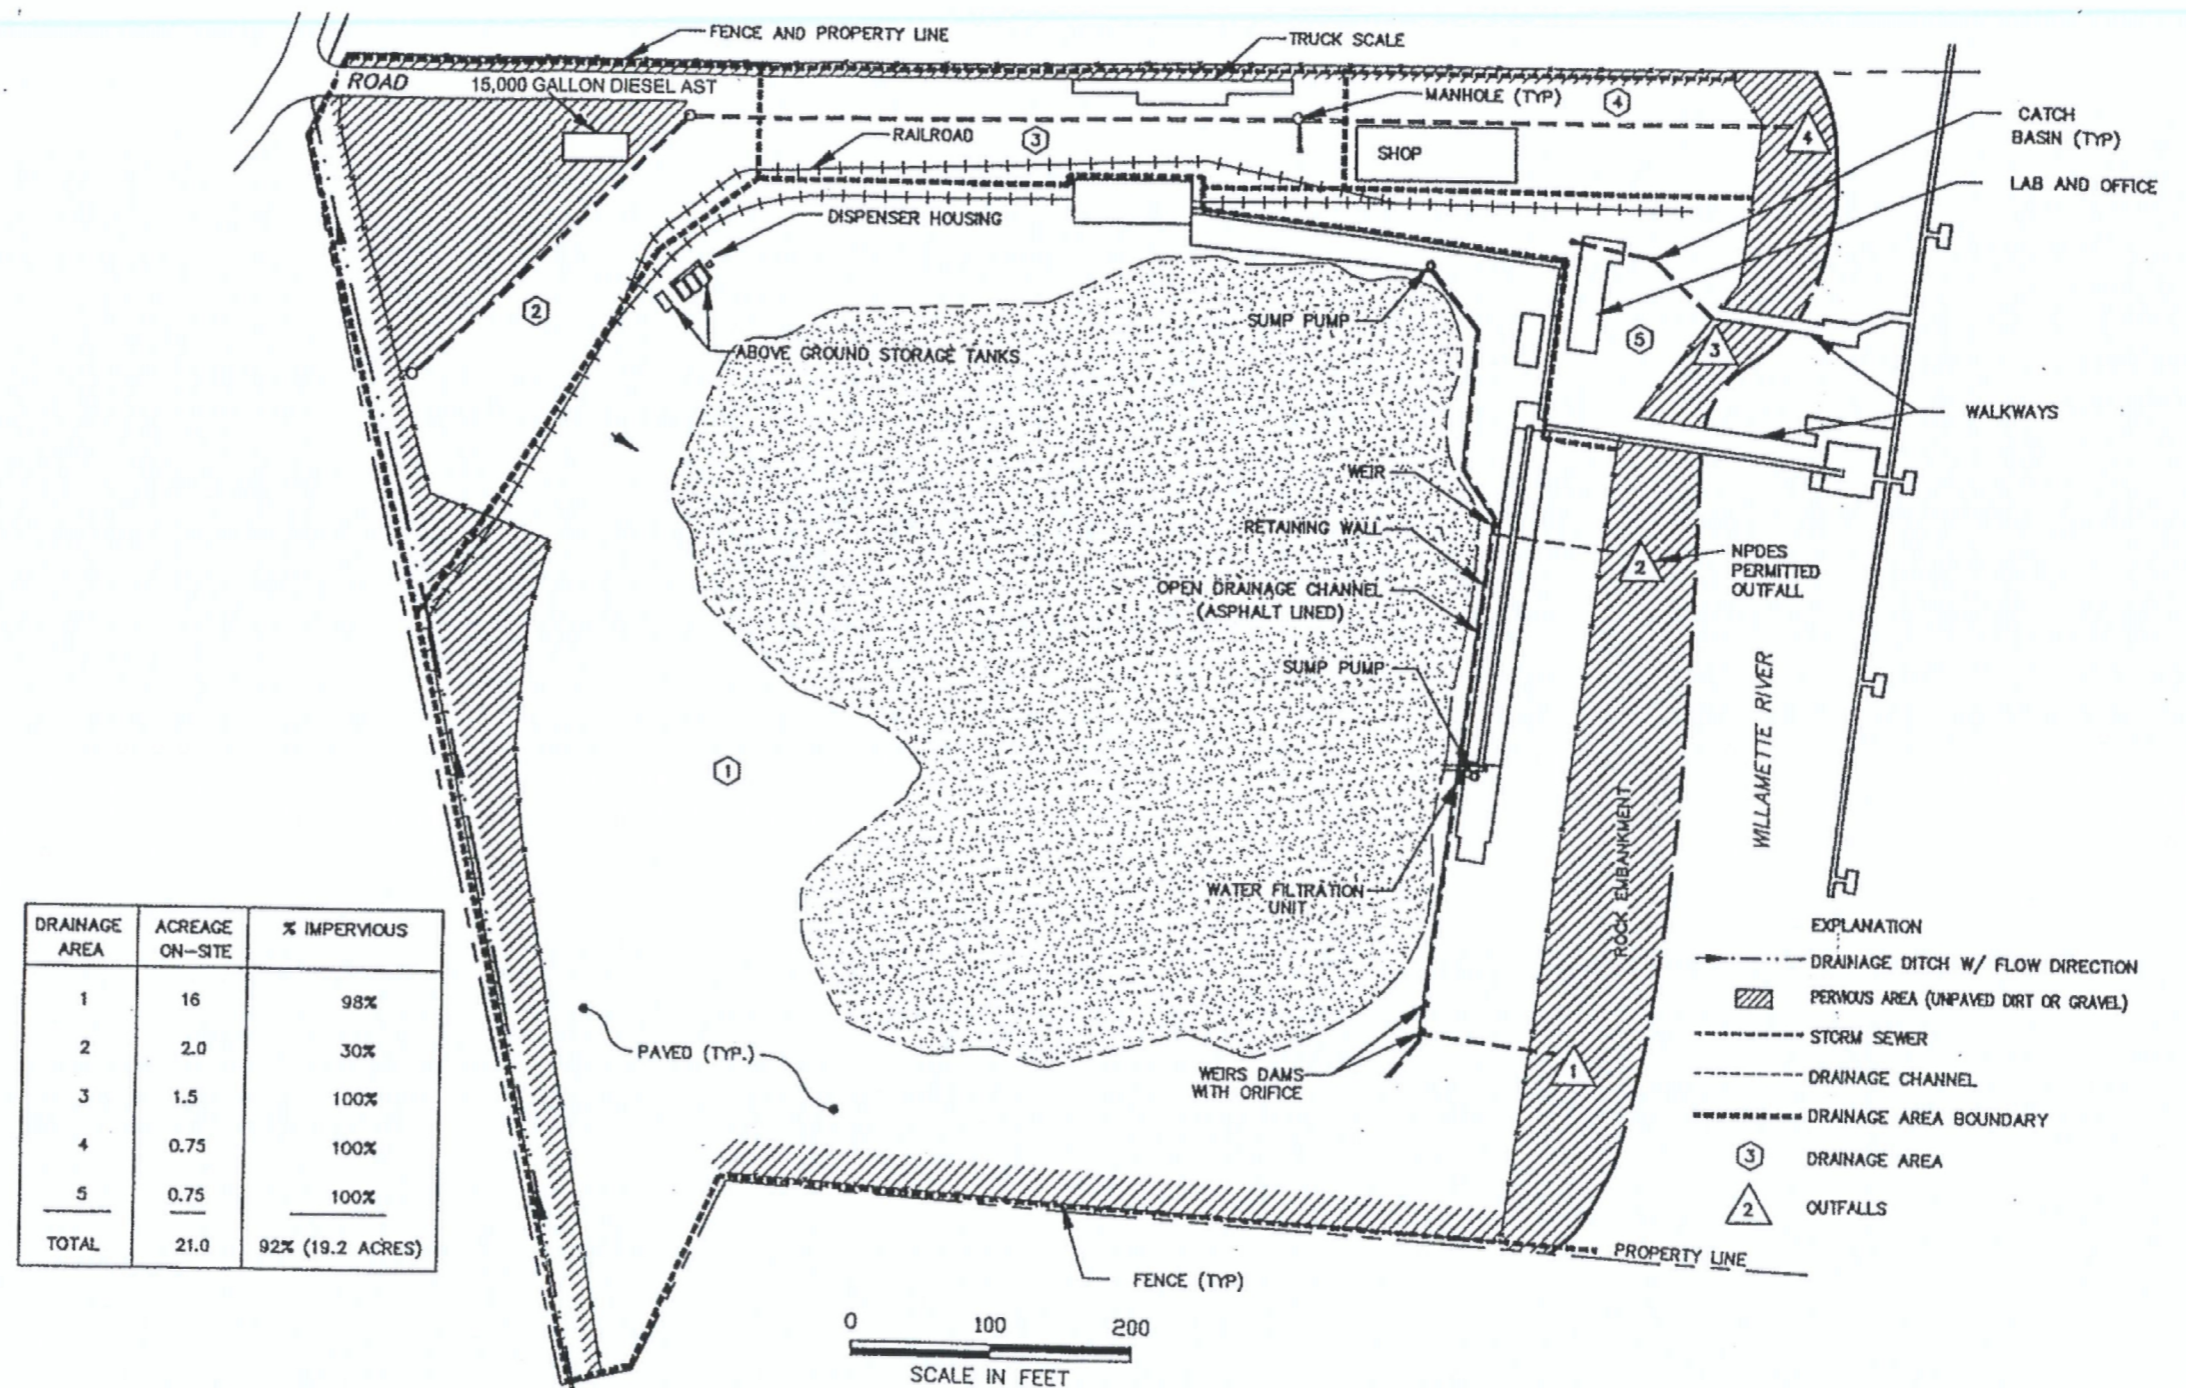
FIGURE 4

Morse Brothers Linnton Facility
12222 NW Marina Way
Portland, Oregon 97231

**SITE STORM WATER
DRAINAGE/OUTFALL MAP**

A total of five drainage areas have been identified at the Georgia-Pacific site, as shown in Supplemental Figure 4 from ESA (2000). Approximately 92% of the 21-acre site is covered by impervious surfaces, and the vast majority of stormwater drains through the site's underground stormwater system to four outfalls. Overland transport of sheet runoff from the uplands to the river is expected to be minimal (see Sections 10.1 and 10.3).

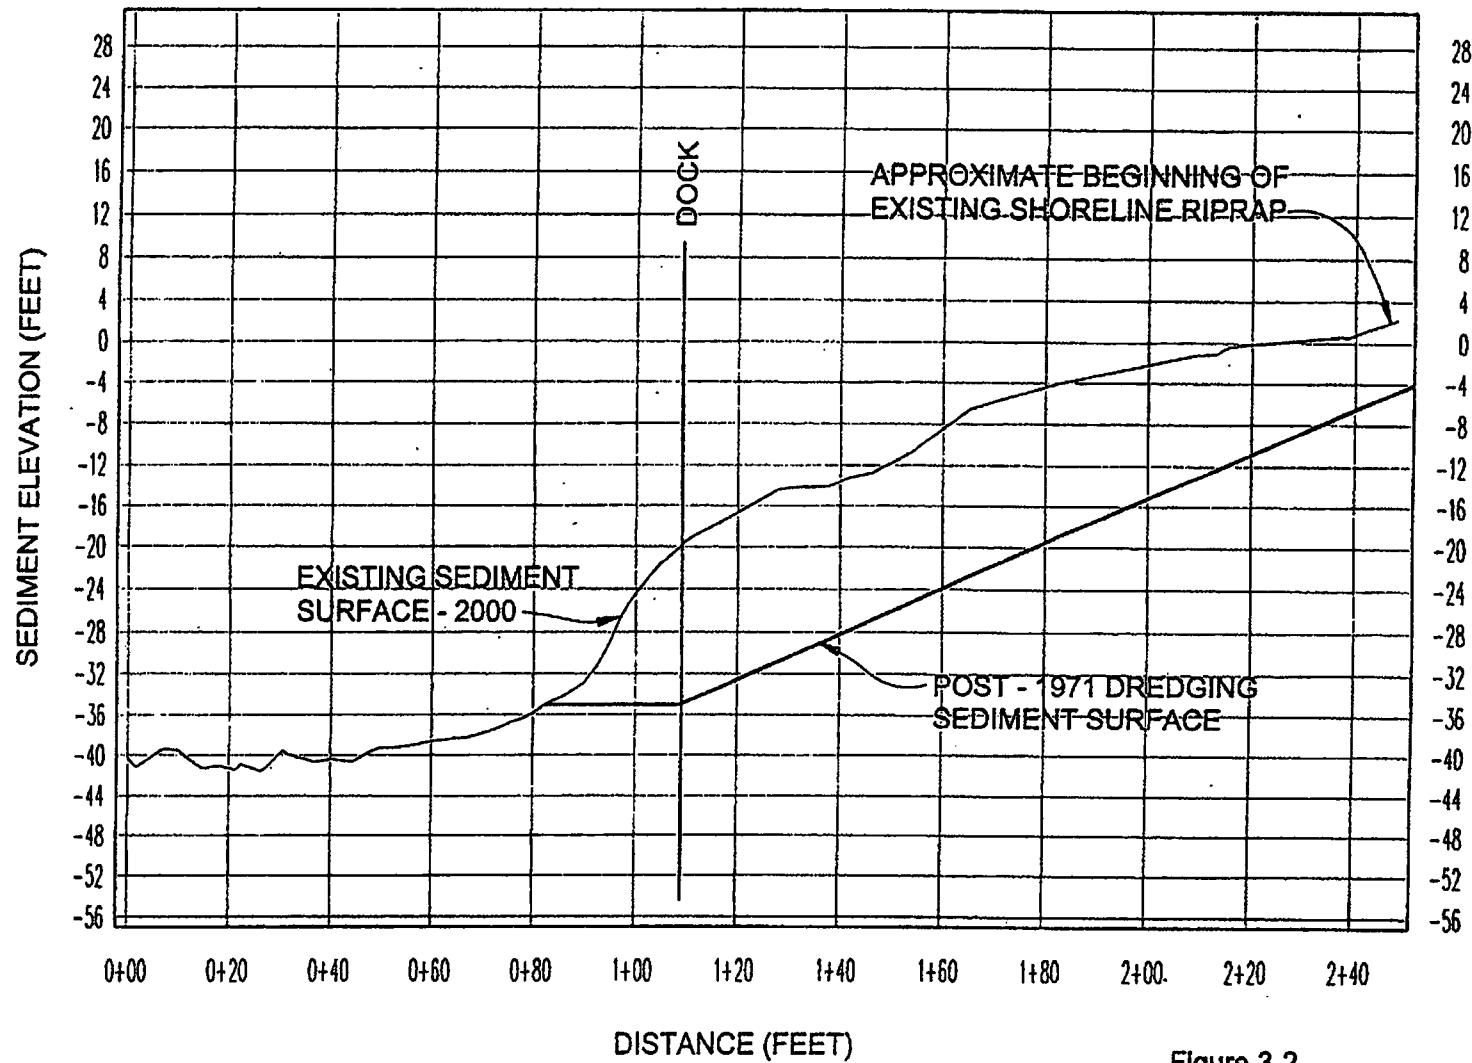
Figure 3-2
CROSS SECTION VIEW, A-A'
Expanded Preliminary Assessment
for the Linton Site

CROSS SECTION A-A'

Figure 3-2. Cross Section View A-A' (CH2M HILL 2000c)

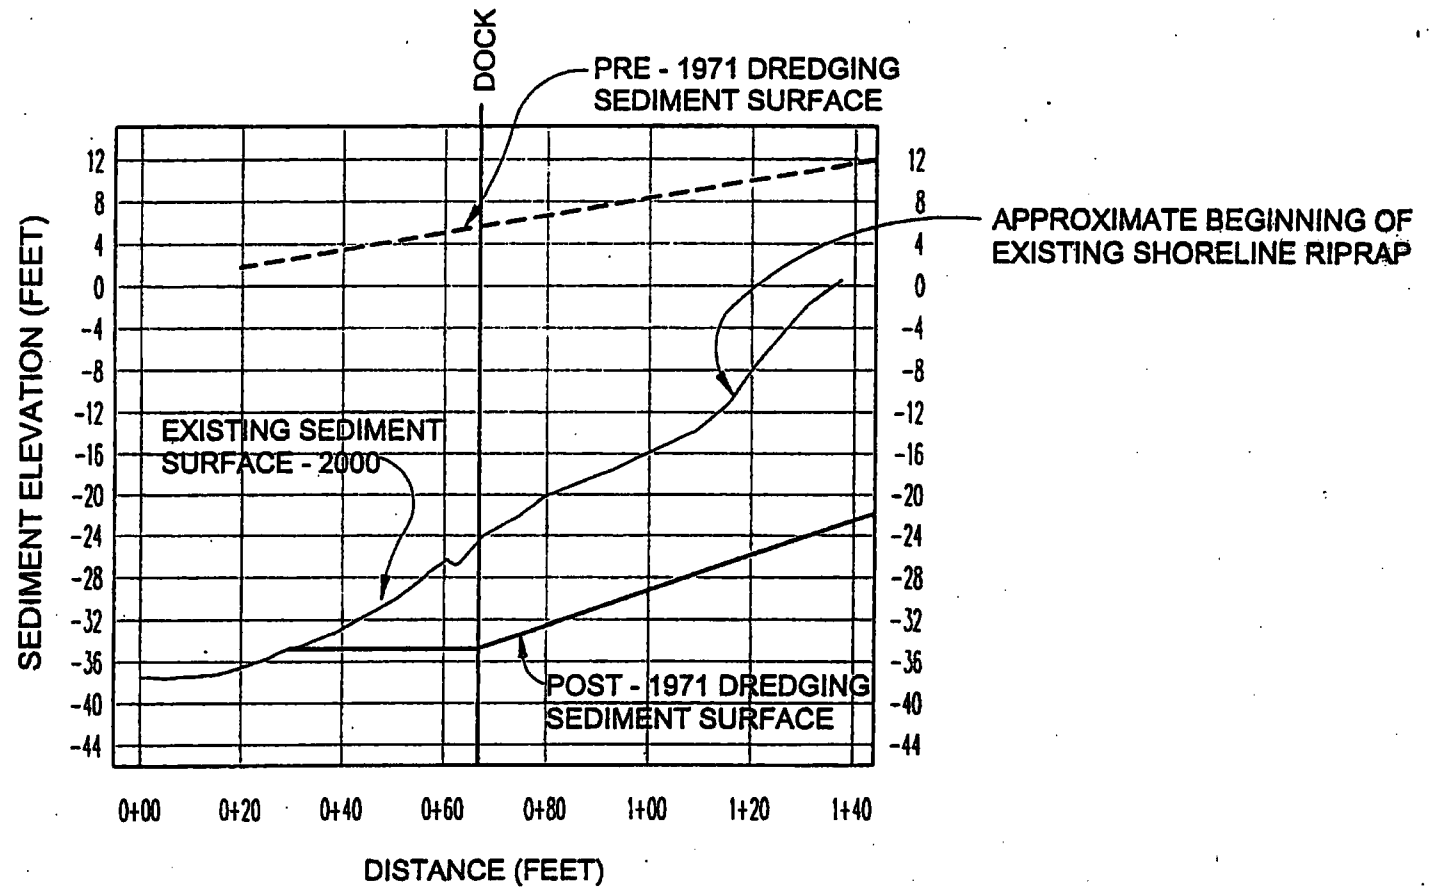
Figure 3-3
CROSS SECTION VIEW, B-B'
Expanded Preliminary Assessment
for the Linnton Site

CROSS SECTION B-B'

Figure 3-3. Cross Section View B-B' (CH2M HILL 2000c)

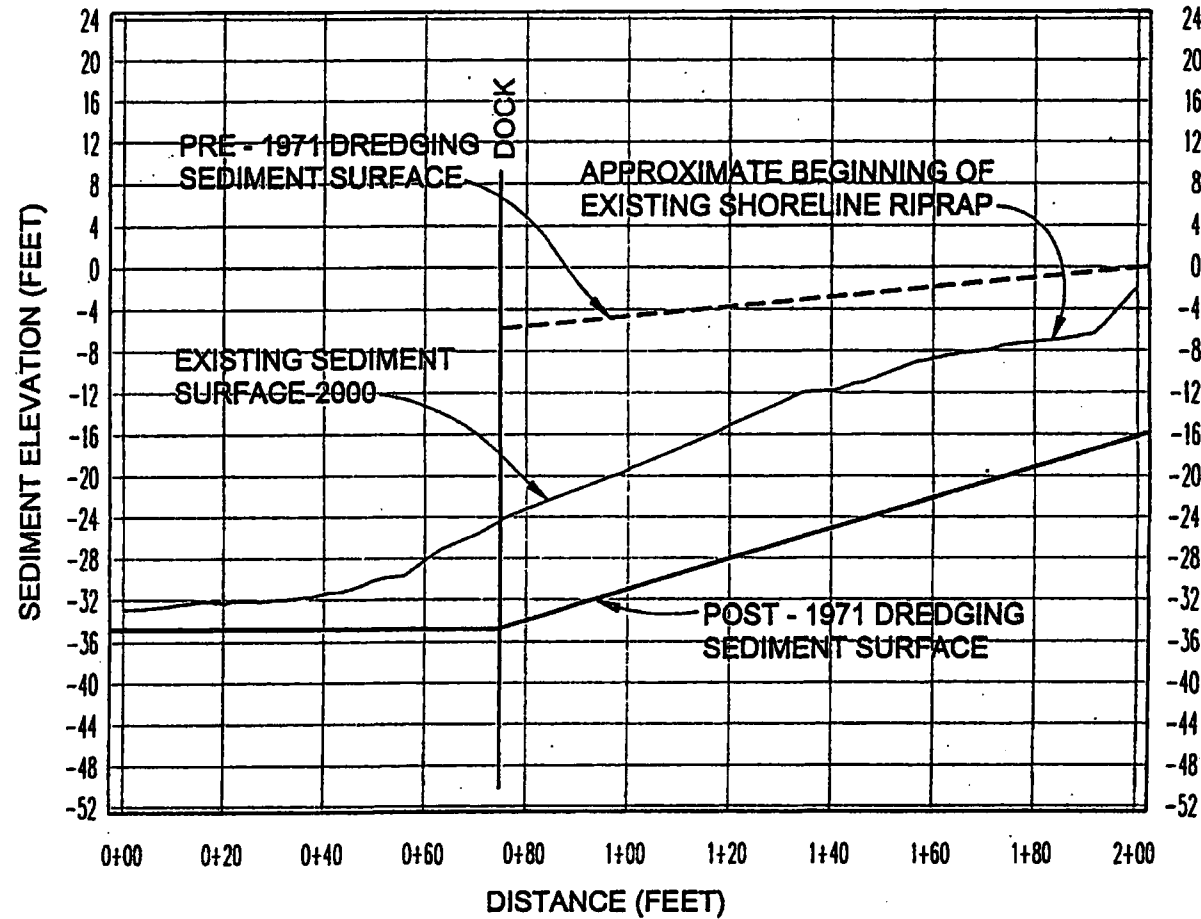
Figure 3-4
CROSS SECTION VIEW, C-C'
Expanded Preliminary Assessment
for the Linnton Site

CROSS SECTION C-C'

Figure 3-4. Cross Section View C-C' (CH2M HILL 2000c)

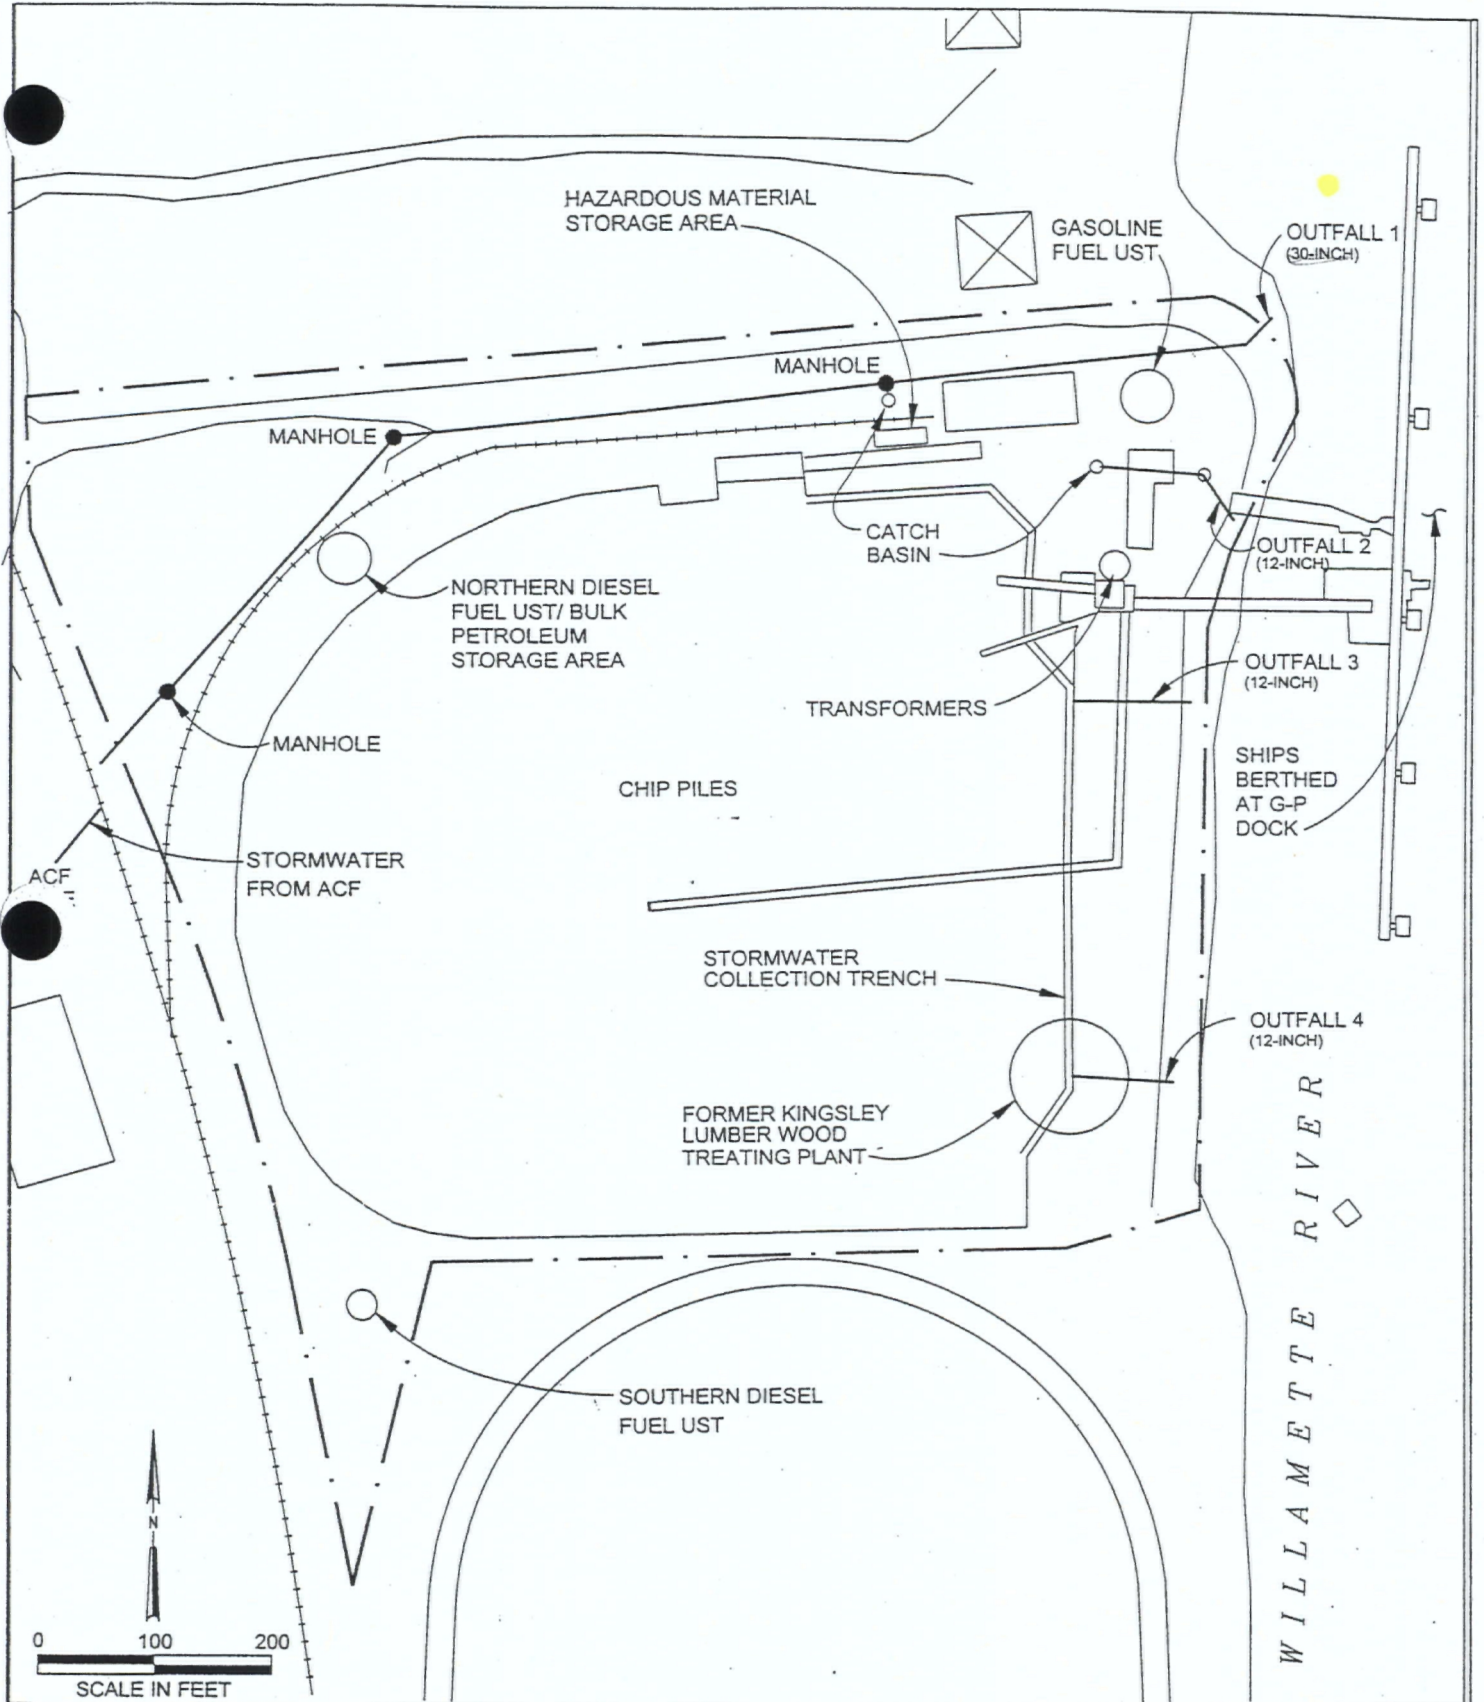
Figure 3-3
SOURCE / PATHWAY
LOCATIONS

Supplemental Preliminary Assessment Report
for the Linnton Site

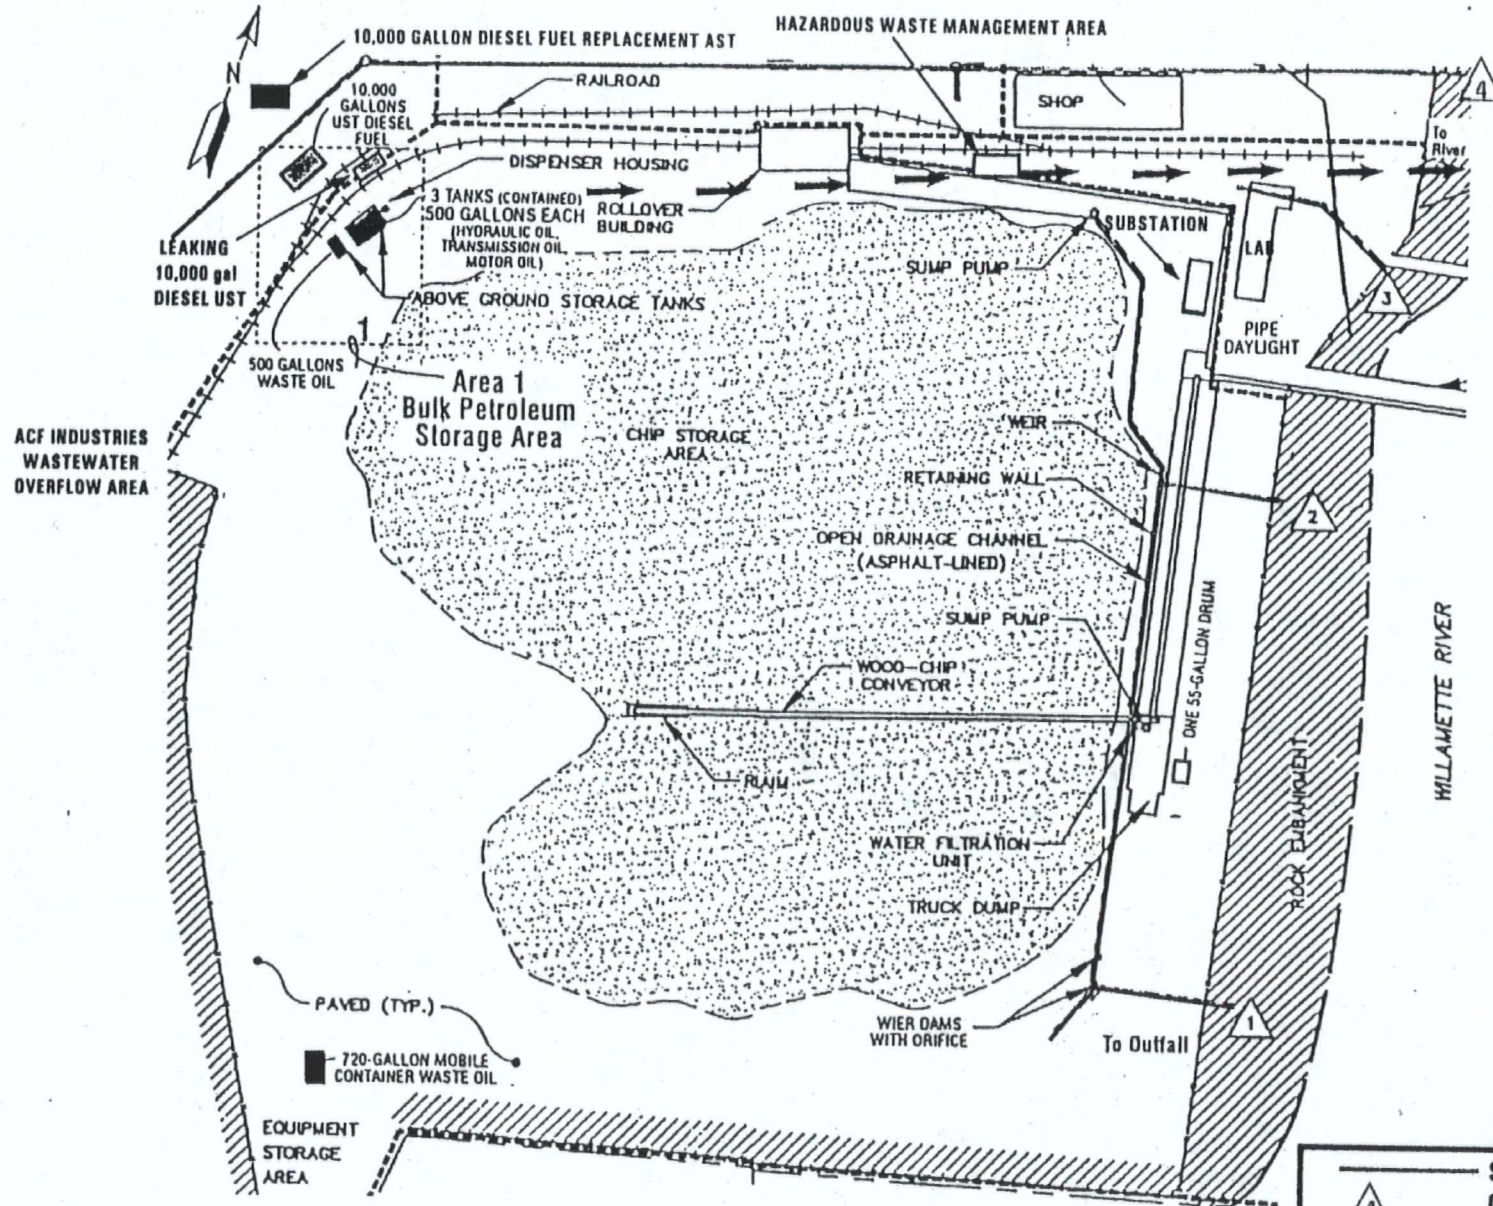
Location of former Kingsley Lumber Company / West Oregon Lumber Company facilities (through late 1950s) on current Georgia-Pacific Fiber Terminal site

- Figure 6: 1950 Sanborn Fire Insurance Map Depicting West Oregon Lumber Company Facilities Located on the Georgia-Pacific Linnton Fiber Terminal Site
- Plate 1:
